LAKELINE

Volume 29, No. 3 Fall 2000

Managing *Aquatic Plants on a Massive Scale*

A Lake Victoria case study

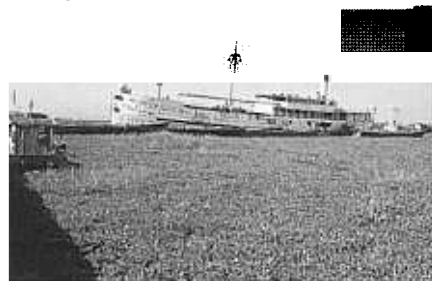
Water hyacinth mats trap a large ship at the Port of Kisumu in Lake Victoria.

The Kenyan coastline and Port of Kisumu have been particularly hard hit by this menacing weed. The huge mats have even prevented large boats from

leaving the harbor.

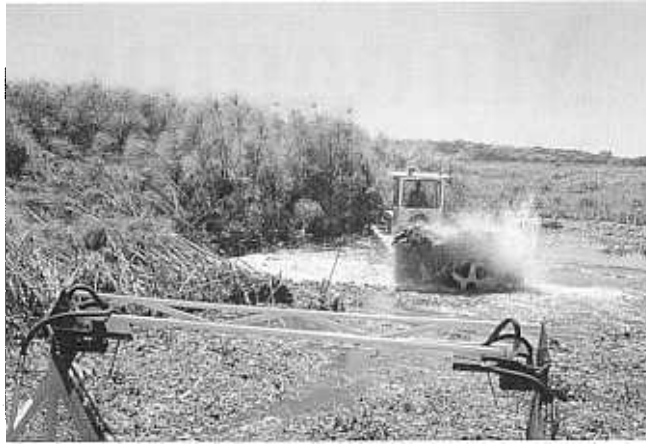
Swamp Devil at work.

We proposed using three Swamp Devil Aquatic Vegetation Cutters to perform the work. The Swamp Devil is a powerful machine fitted with two circular cutting blades on the bow that also serve to propel and steer the vessel. It can trench channels nearly three feet deep and eliminate brush and trees up to four inches in diameter. By using a special double blade system, the machine could shred the water hyacinth into small pieces, thus fulfilling the contract requirements.

This secondary weed growth made executing the job more difficult as well, but it was handled by the Swamp Devils almost as readily as chopping the hyacinth itself. By working two shifts seven days a week, the 12-month contract was completed in only five months. That the work was finished in

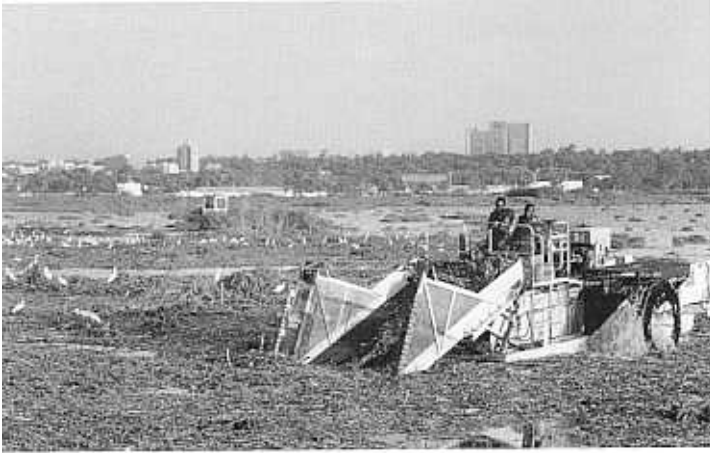
A medium-sized harvester cleans up the floating debris remaing from the chjopping work.

Nature played a helpful role in the disposal of the chopped vegetation. At the end of each day the trade winds reversed and carried away most of the material not collected by the harvester, dispersing it over a large area. While touring the bay at different times we observed scattered bits of slightly submerged decaying vegetation. The fragments created no navigational hazard and were barely noticeable. In a short time there was no evidence of the fragments.
